Bonded Fibre Reinforced Polymer Strengthening in a Real Fire

T.J. Stratford^{*}, M. Gillie, J.F. Chen and A.S. Usmani

Institute for Infrastructure and Environment, School of Engineering, The University of Edinburgh, UK.

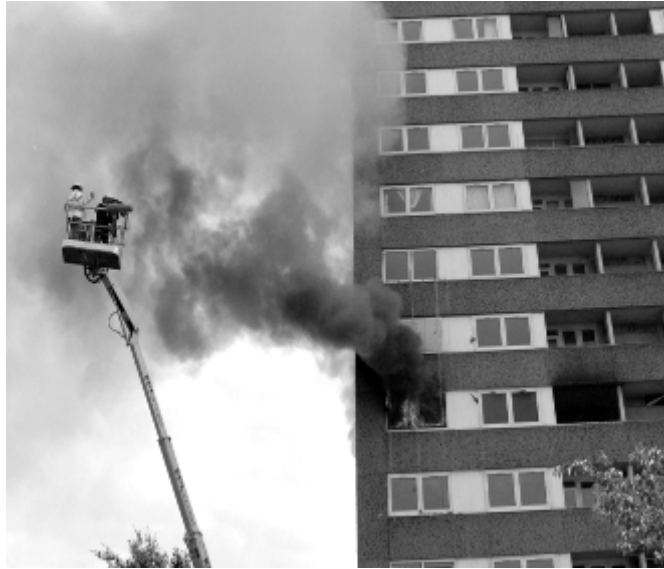
Figure 1: The Dalmarnock Fire Test in progress (Test 1).

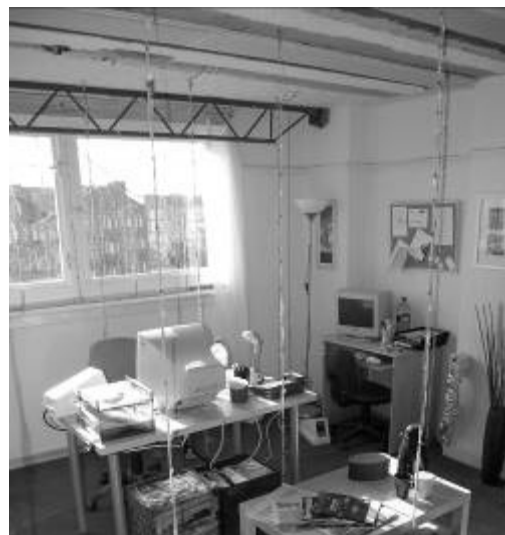
Figure 2: The Test 1 fire compartment, showing the FRP installed on the ceiling.

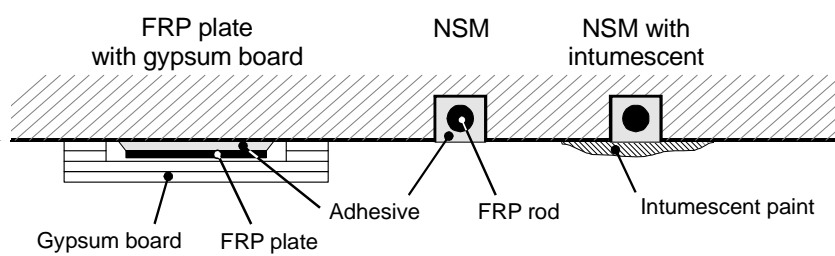
The gypsum board protection used 12mm board to form a box around the strengthening, with two layers of board below the strengthening (Figure 3). The joints in the boards were staggered and the gaps filled with a fire resistant sealant.

Figure 3: Types of FRP strengthening and protection (schematic)

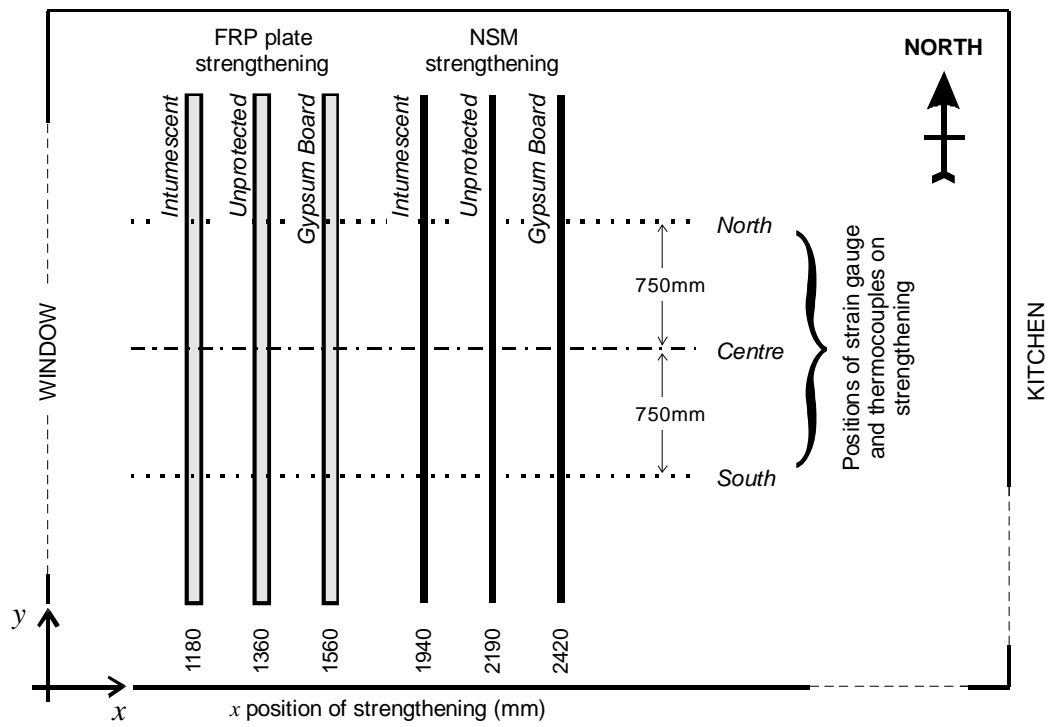
The bonded FRP strengthening in Test 1 was instrumented with thermocouples and strain gauges prior to installation. Thermocouples were loosely attached to the FRP plate or bar at the North, Centre and South positions shown in Figure 5. The thermocouples were thus

Figure 5: Schematic plan of the strengthening.

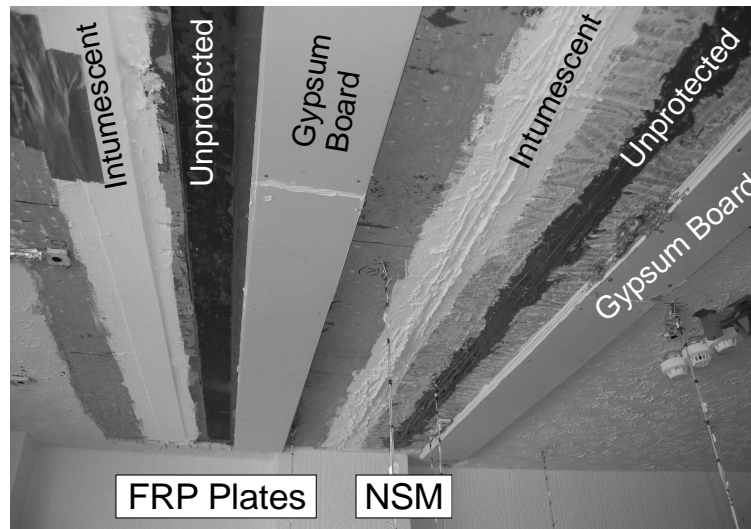
Figure 6: The six strips of FRP strengthening and protection installed in Test 1.

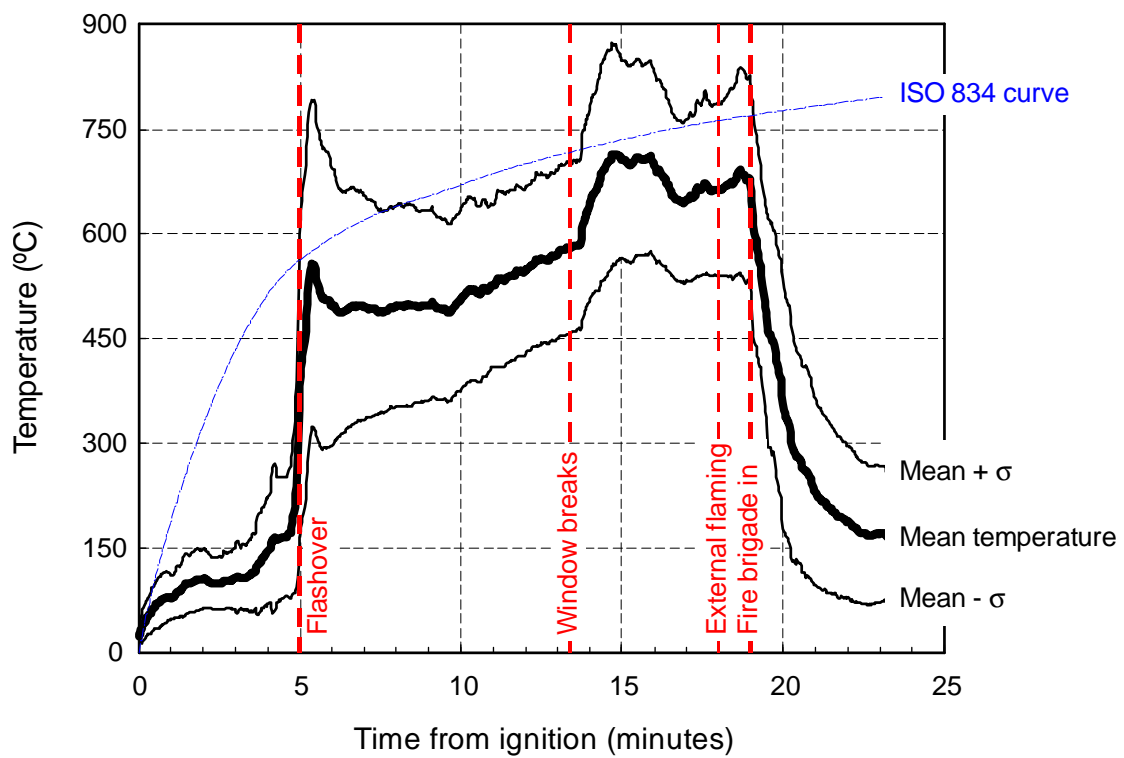
Figure 7 shows the Test 1 fire development in terms of the gas phase temperatures measured within the compartment. It shows the mean temperature from the 240 thermocouples that recorded the 3D temperature field within the fire compartment. Two further curves plot the mean temperature plus and the mean minus one standard deviation to indicate the spatial variation in temperatures through the compartment. The ISO-834 time-temperature curve is included as a benchmark against which the experimental results can be compared. Figure 7 shows the three main phases of the fire:

plate exceeded 65°C before flashover occurred, when the gas phase temperatures were far lower than the ISO-834 curve used in laboratory fire tests (Figure 7). At all other measurement positions with reliable measurements, 65°C was reached very soon after flashover which occurred at 5 minutes. It is clear here that it took slightly longer for the temperature to reach 65°C in the NSM strengthening compared with the nearby location in the externally bonded plate (Table 2), because the thermocouples on the NSM strengthening are deeper within the structure.

Figure 7: Development of gas phase temperatures in the Test 1 compartment (mean \pm 1 standard deviation).

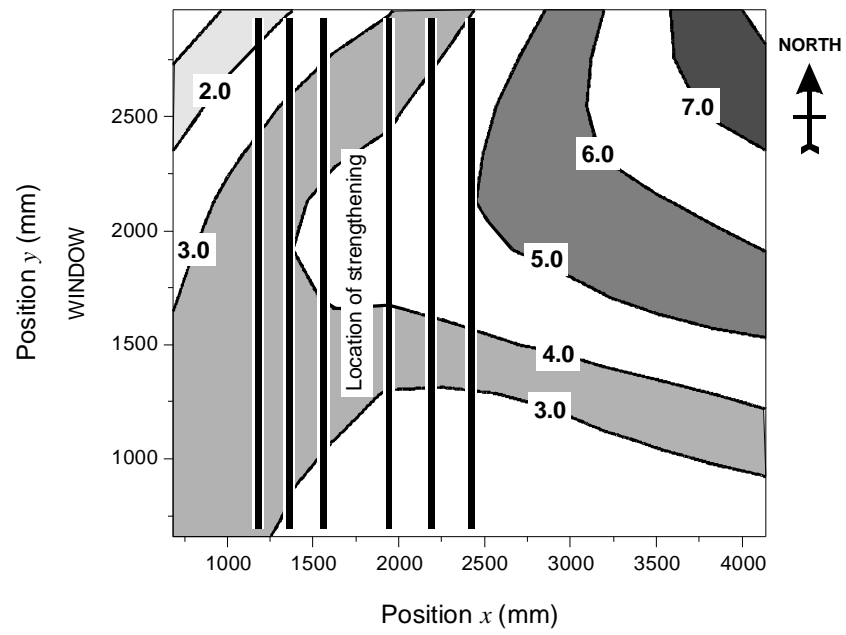
The peak heat release rate during the fire was 800kW. The heat flux incident upon the ceiling of the compartment at four minutes after ignition is shown in Figure 8. This illustrates the spatial variation in heat fluxes both across the room and across the region of FRP strengthening.

- The intumescent protected plate (Figure 9b) also separated from the concrete, except for a short length at its southern end, where it remained bonded to the concrete. Away from the southern end, the matrix polymer had burnt away to expose the fibres. The bonding adhesive that remained on the ceiling was charred. It should be noted that the gas phase temperatures show a cool region in the south west corner of the room. This is also evident in Figure 8 which shows less heat flux in the south.

Figure 8: Heat flux incident on the ceiling in the Test 1 compartment (kW/m^2), 4 minutes after ignition.
